## Case Study – Ru’s Pierogi

Architect: Schneider Design Architects, Buffalo, NY  
 August 19, 2016

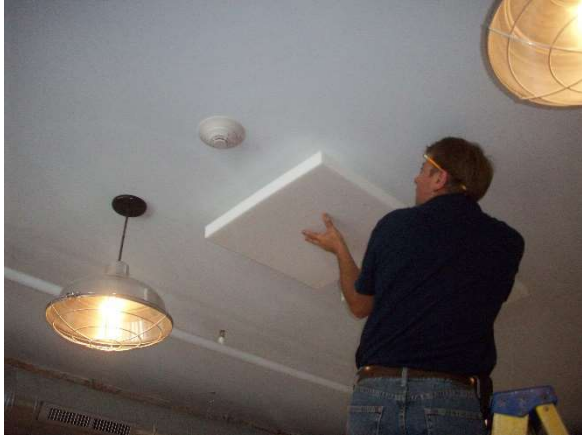
Figure 1: Gypsum board ceiling during installation

**The Problem:** The dining area of the protected ordinary construction building (Type III-A) has a gypsum board ceiling to provide fire protection for the wooden floor construction above. The area, approximately 38’ long x 34’ wide x 10’-6” high, contains a dining area as well as a finish prep area with fryers and a large hooded exhaust fan that produces a constant background of 59 dBA. Brick and glass walls, concrete floor, and gypsum board ceiling produced an average reverberation time of **1.5 seconds**. The noise and reverberation made conversation difficult.

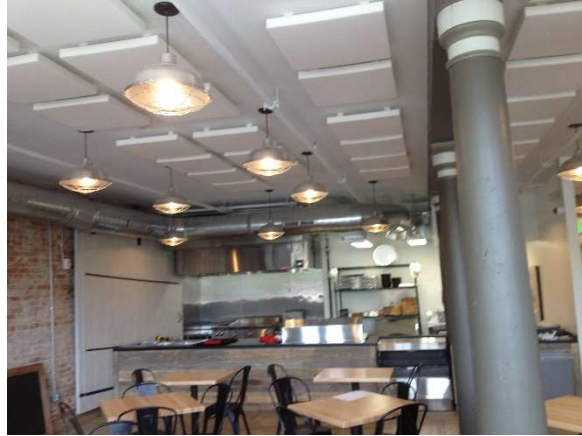
Figure 2: Dining and prep area after installation

**The Solution:** Approximately 192 sf of 2-inch-thick **STC Hi-Sabin™ Panels** were mounted with foam standoffs and adhesive onto the gypsum board ceiling. Reverberation time has been cut to **0.8 second** and provides an ideal acoustical environment for dining.
